International Conference on Case Histories in
Geotechnical Engineering

Ground Improvement by Stone Columns and Surcharge at a Tank Site

GROUND IMPROVEMENT BY STONE COLUMNS AND SURCHARGE AT A TANK SITE

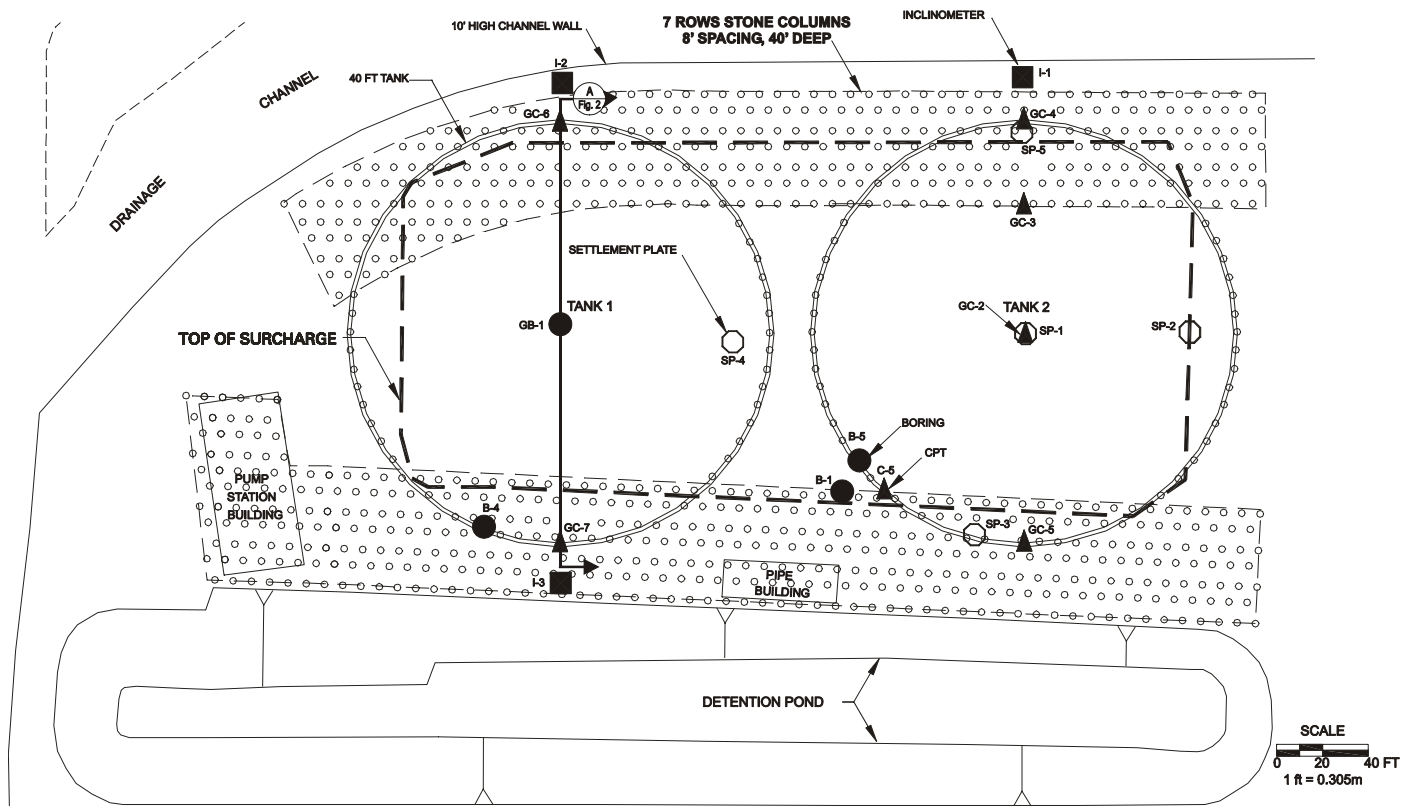
Fig. 1. Site Layout

- The lot is roughly rectangular in shape, measuring about 560 ft (171 m) in the east-west direction and 330 ft (101 m) in the north-south direction. Site layout is shown in Fig. 1. The tank site has grades ranging between El. 33 to El. 35 feet (10.1 to 10.7 m).
- A new detention pond with a depth ranging from 6 to 10 ft (1.83 to 3 m) and 3:1 (horizontal to vertical) side slopes was planned to be constructed about 25 ft (7.6 m) south of the reservoirs.
- The site is bounded on the north, and along the northwest corner, by a 10-ft (3-m) deep concrete-lined drainage channel with vertical side retaining walls.

The vertical 10-ft (3-m) high wall of the drainage channel is located about 25 ft (7.6 m) north of the two reservoirs (Fig. 1). Tank foundations were proposed at roughly 10 ft (3 m) above channel invert elevation. In addition, a detention pond was proposed about 25 ft (7.6 m) south of the two reservoirs. The detention pond was proposed with 3:1 (horizontal to vertical) side slopes and the bottom of the pond was up to 10-ft (3m) below the tank foundations. The presence of these low-lying areas results in reduced lateral stability compared to tanks on level ground. Results of stability analyses performed by PCSTABL/5M are shown in Fig. 3. For seismic stability, we used a pseudo-static coefficient of 0.15, and we reduced the shear strength of the soft to firm clay to 80% of the static shear strength. The calculated factors of safety for static and seismic conditions are 1.3 and 0.9, respectively, and are lower than the normally used values of 1.5 and 1.1, respectively. Since the calculated factor of safety for pseudo-static analysis was less than 1.1, we estimated that potential for large lateral movements using simplified Newmark-type analysis (Blake et al., 2002) was present during the design earthquake.

Three inclinometers were established along the north and south sides of the tanks near the channel and detention pond to measure lateral movements due to stone column installation and surcharge. Four survey points were set on the top of the channel wall to monitor both settlement and lateral movement of the channel wall. Five settlement plates, SP-1 through SP-5, were installed before placement of the surcharge to monitor settlement. The locations of these instruments are shown in Fig. 1.

- Inclnometers were installed at the locations shown in Fig. 1.
- Stone columns were installed along the northern and southern tank boundaries, adjacent to the drainage channel and detention pond. To minimize lateral movement and damage to the channel wall, the closest stone columns were kept at a minimum distance of 12 ft (4 m) from the wall. A total of 908 stone columns were installed in 54 days.

- Installed settlement plates SP-1 through SP-5.
- After completion of the stone columns, import fill was placed to preload the site to the boundaries shown in Fig. 1. The placement of about 80,000 cubic yards (61,210 cubic meters) of fill was completed from April 16, 2001 through May 30, 2001 a period of about 45 days.

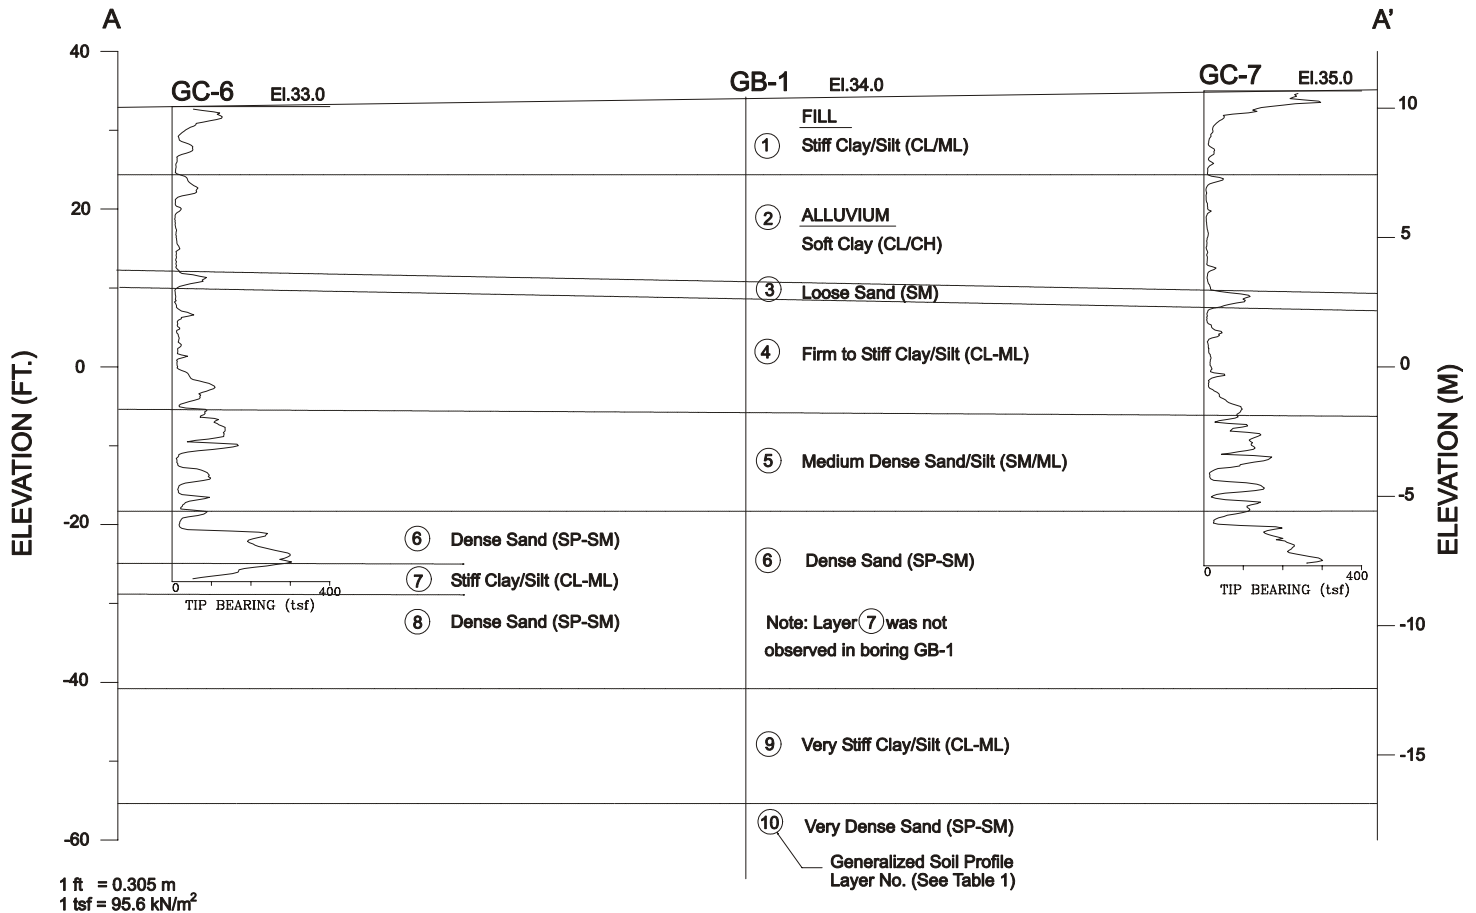
Fig. 2. Generalized Soil Profile

Based on data from the borings and CPTs, the soil profile is relatively uniform. Beneath a cap of stiff clay/silt man-made fill soils, deep alluvial sediments underlie the site. Above El. -18 ft (5.5 m), the alluvial sediments consist primarily of compressible soft to stiff clay/ silt layers, with isolated zones of loose to medium dense sands. Below El. -18 ft (5.5 m), the sediments consist of dense to very dense sands and stiff clays. We developed a generalized soil profile including strength and compressibility parameters shown in Table 1. A generalized cross-section illustrating the soil profile is shown in Fig. 2. The groundwater was present at depths ranging from 10 to 16 ft (3 to 4.9 m) below existing grades.

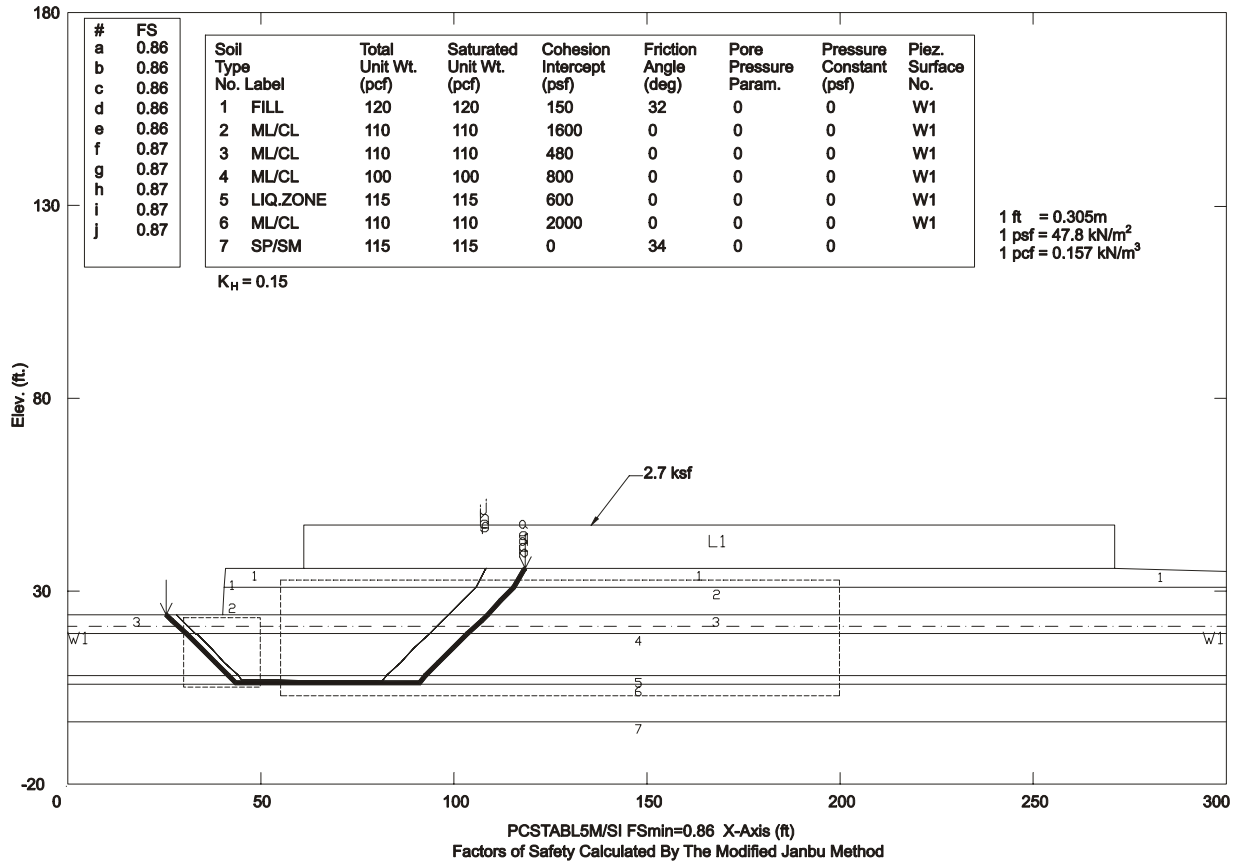
Fig. 3. Stability Analyses

WATER TANK, H=40FT, SEISMIC, BLOCK SURF., UND. COND.

Ten Most Critical

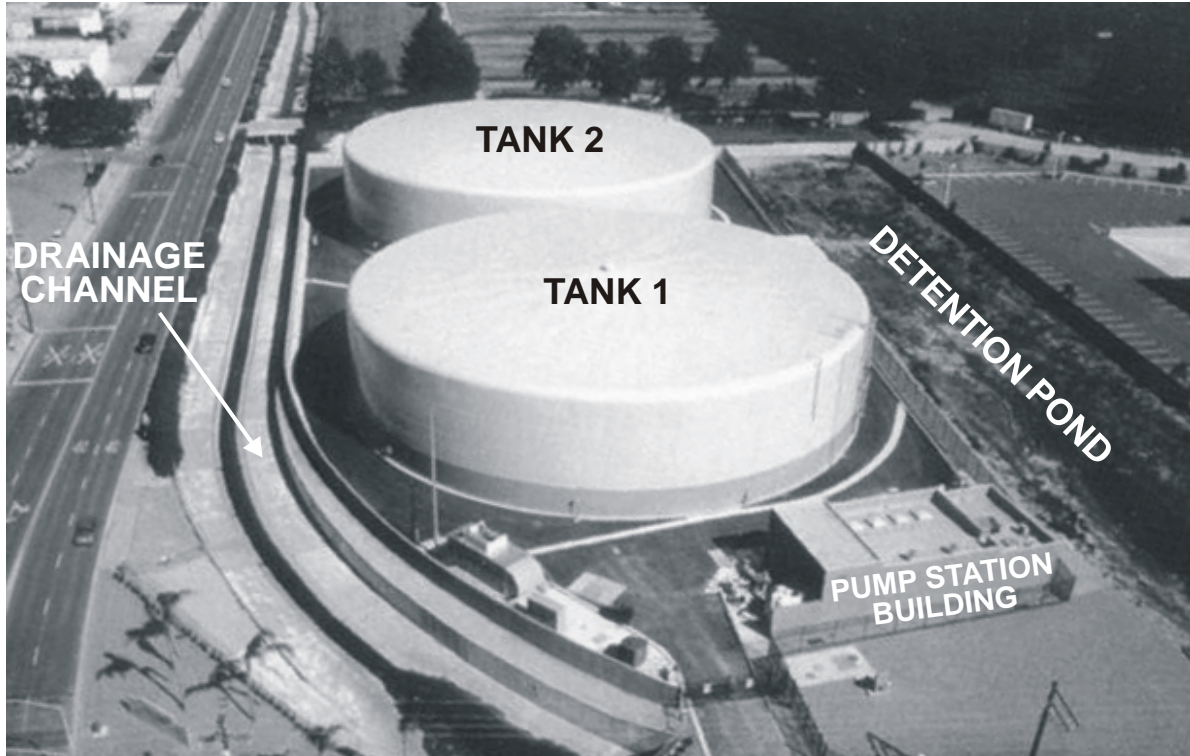
Photo 1. Aerial View of Tanks

The two tanks, pump station, and other facilities are shown in Photo 1.

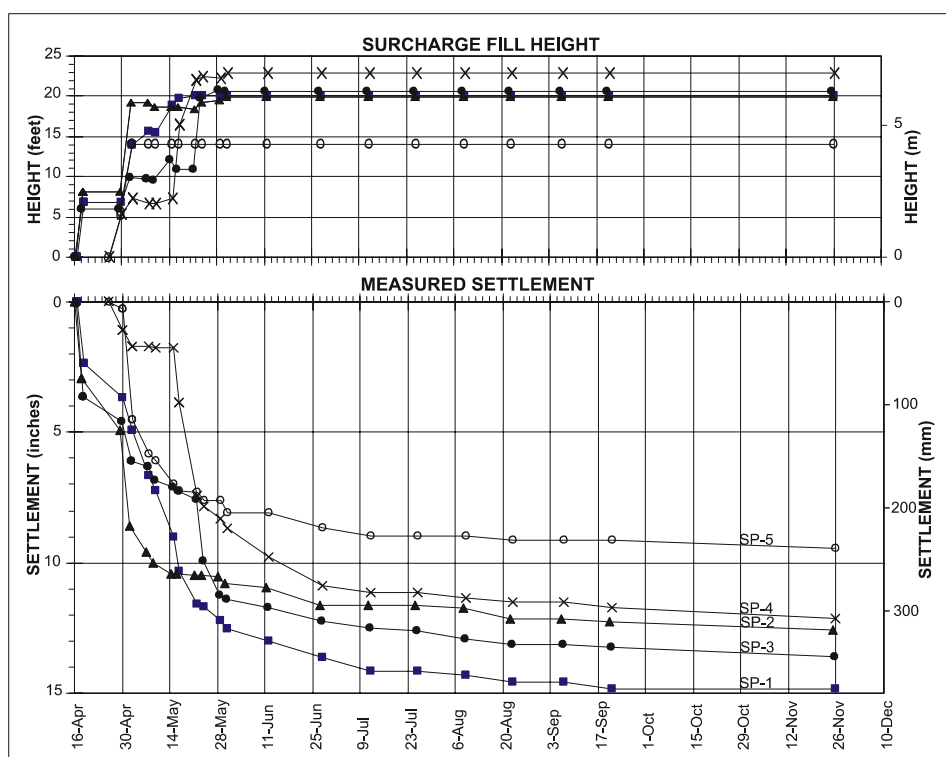
Fig. 4. Surcharge Settlement

The settlement data from plates SP-1 through SP-5 is presented in Fig. 4. The following observations can be made from a review of Fig. 4.

- The measured settlement ranged between 9.1 and 14.6 inches (231 and 371 mm). The smallest settlement at 9.1 in. (231 mm) for plate SP-5 is for a plate on the slope. Plate SP-4 was located in an area where previous fill had been stockpiled and thus, has less settlement. The settlement at the other three plates ranges between 12.2 and 14.6 inches (310 and 371 mm). These values compare favorably with the predicted settlements under the surcharge.
- The data in Fig. 4 indicates that the settlement had leveled off in about 100 days after the completion of the surcharge or about 5 months after the start of the surcharge. Depending on the rate at which the surcharge was placed, 90% of the settlement was completed in the first 30 to 45 days after the completion of the surcharge.
